Taking in the views

Bachy Soletanche's anchor, grout and mini-piling division was enlisted to carry out a two-phase stabilisation project on the conduit section of the Thirlmere aqueduct near Grassmere, writes project manager Andy Tucker

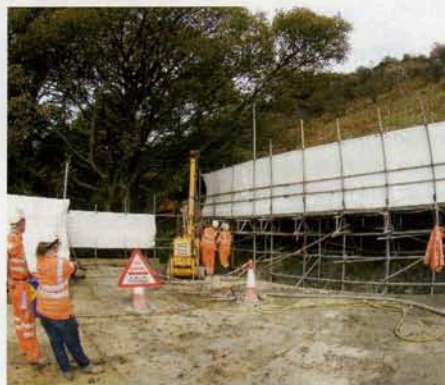
A platform off a 40° cliff face had to be installed to enable remedial works to proceed

A permanent solution was required to support the conduit, and remove any potential ground movement immediately above and below it; all of which required moving the necessary machinery up the 440m-high Nab Scar fell and creating a platform off the down slope.

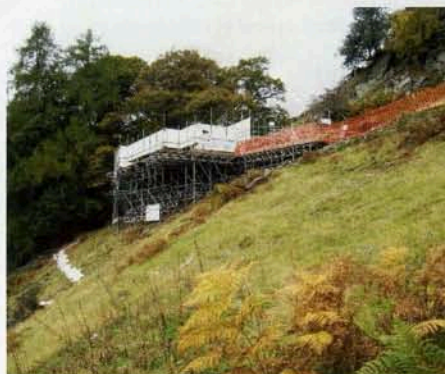
Bachy Soletanche working on a 440m fell in Nab Scar, Lake District, to conduct remedial works on the United Utilities-owned Thirlmere Aqueduct
